Road tunnel civil engineering inspection guide

Book 2: Catalogue of deteriorations

January
2015

Centre d'Études des Tunnels

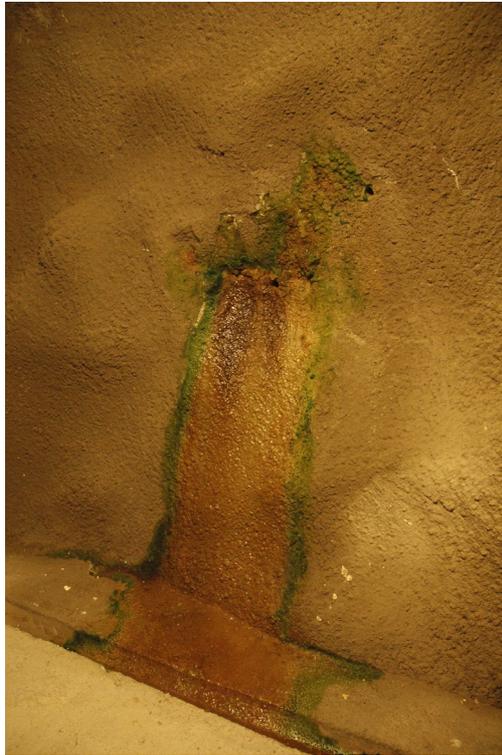
Figure 1: water ingress on a sprayed concrete lining

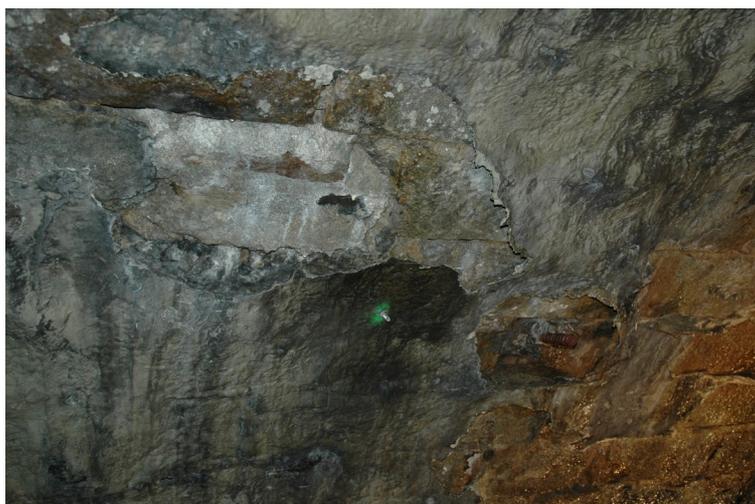
Figure 2: deteriorated waterproofing coating caused by water ingress (due to poor workmanship and effects of freezing)

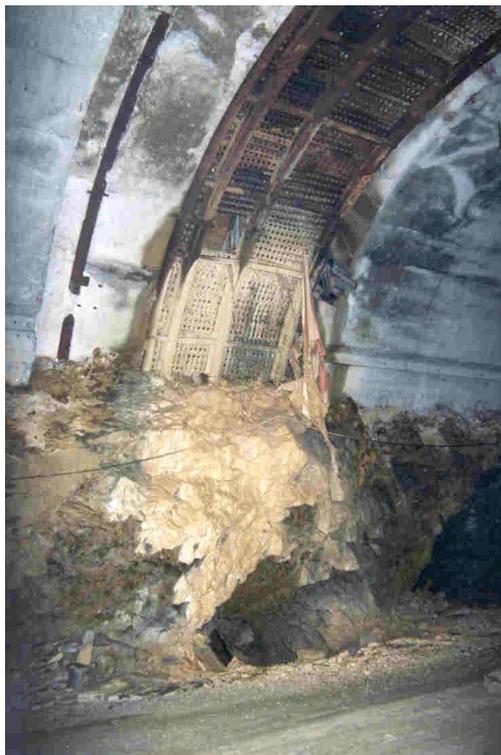
Figure 1: limestone concretions encrusting the opening of an active karst in an abandoned tunnel

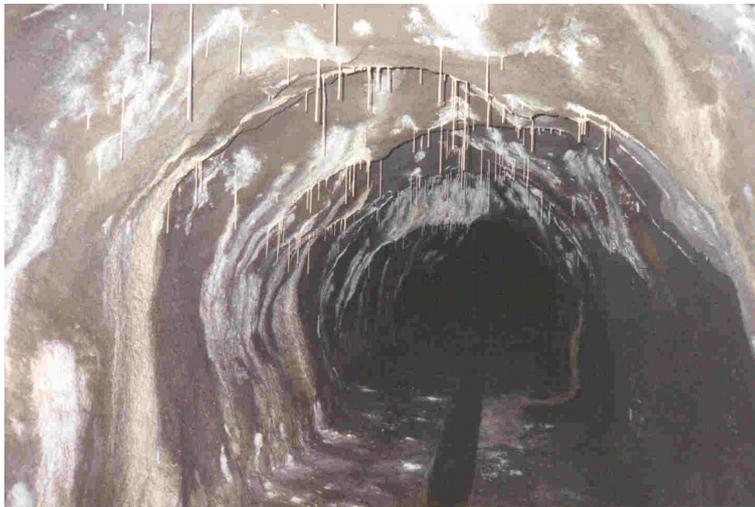
Figure 2: stalactites and white calcite flowstones on sprayed concrete (dissolution of the lime in the cement due to water percolating from the ground)

Concretion caused by water seeping in from the ground generally has a beige to yellowish colour which indicates impurities fixed by the calcite. Conversely, calcite coming directly from the dissolution of lime in the concrete is very white; it highlights fine cracks or forms stalactites or flowstones on the facing. These two types of calcite are also found in drainage systems.

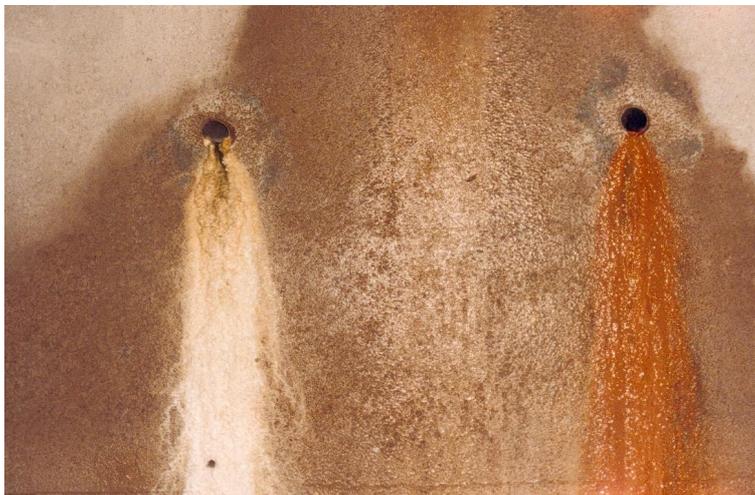
Figure 3: light calcite concretions (on the left); red gel deposit, rich in iron oxide (on the right)

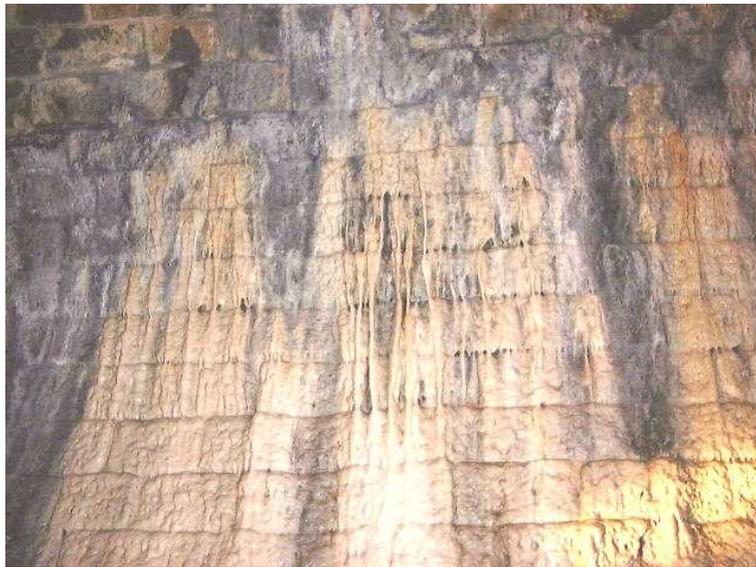
Figure 5: calcite concretions on stone masonry

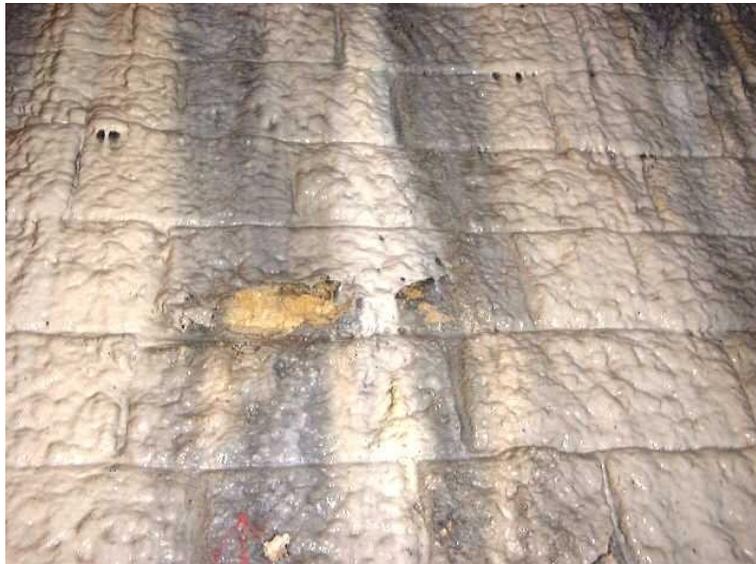
Figure 6: stone masonry encrusted with calcite concretions

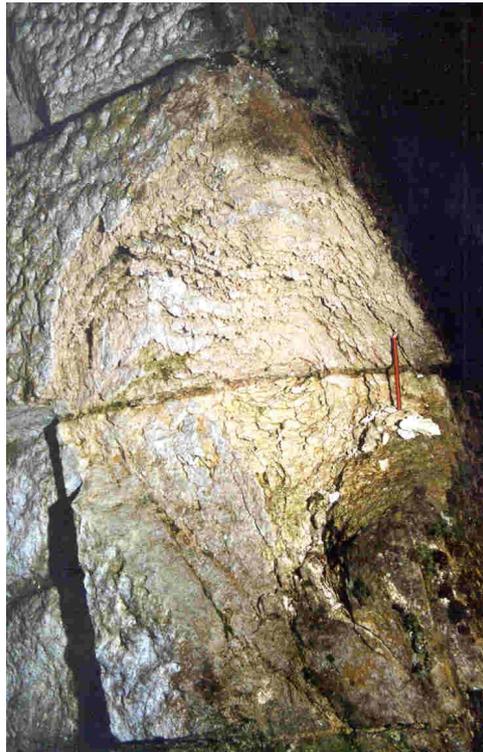
Figure 1: effects of freezing on large oolitic limestone stones

In stonework, the porosity of the rock, which may be natural or due to thermal or structural stresses, facilitates water seepage and renders the material more vulnerable to the effects of freezing. Oolitic limestone, dolomite and sandstone are among the most sensitive rocks.

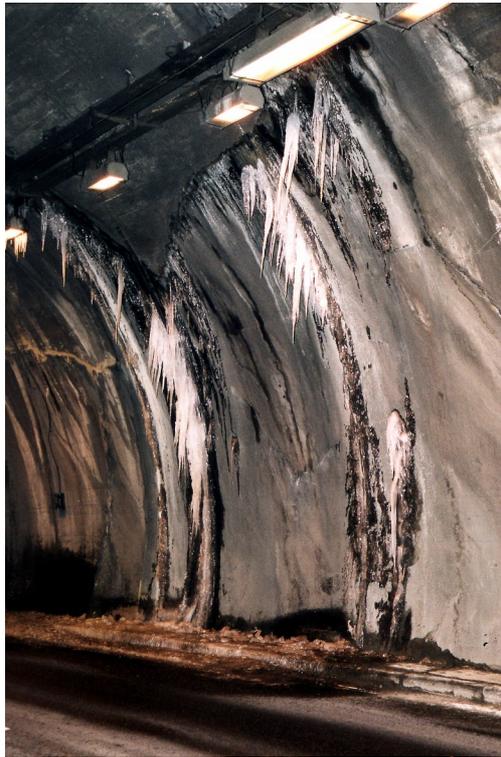
Figure 2: stalactites and packs of ice on the ground

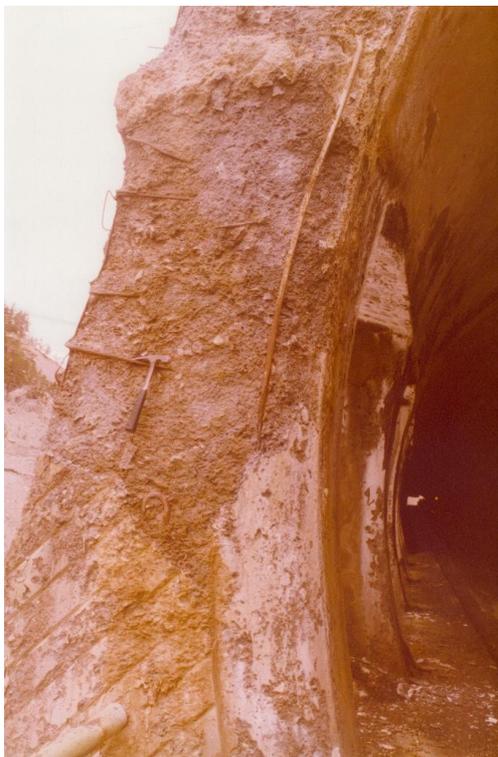
Figure 4: frozen reinforced concrete side wall

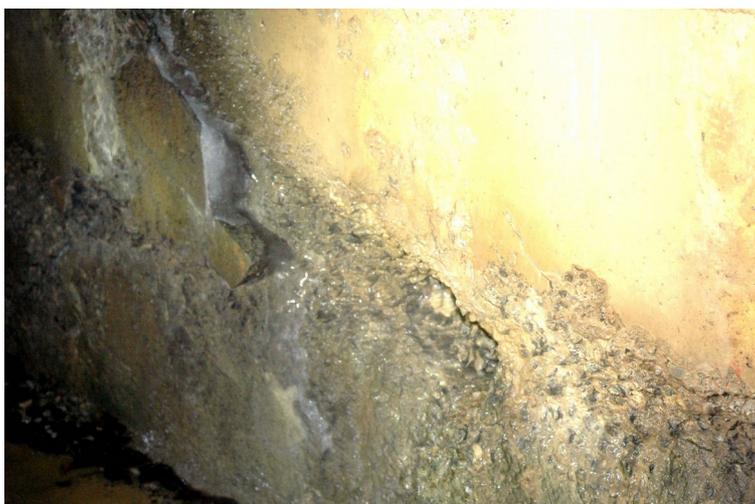
Figure 5: spalling of concrete due to freezing, at the bottom of the side walls

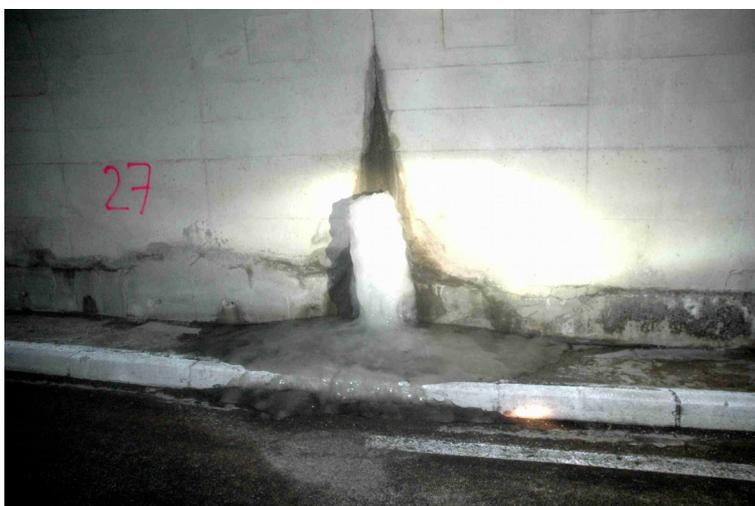
Figure 6: pack of ice coming from a joint and spreading onto the walkway

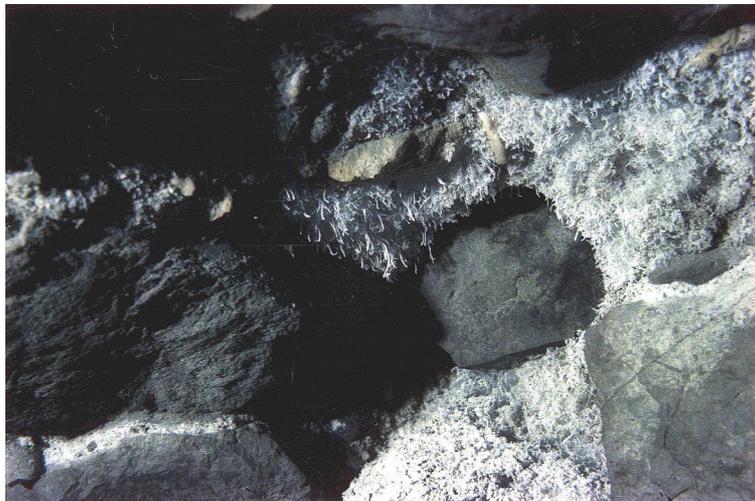
Figure 1: efflorescence on old lime-based mortar

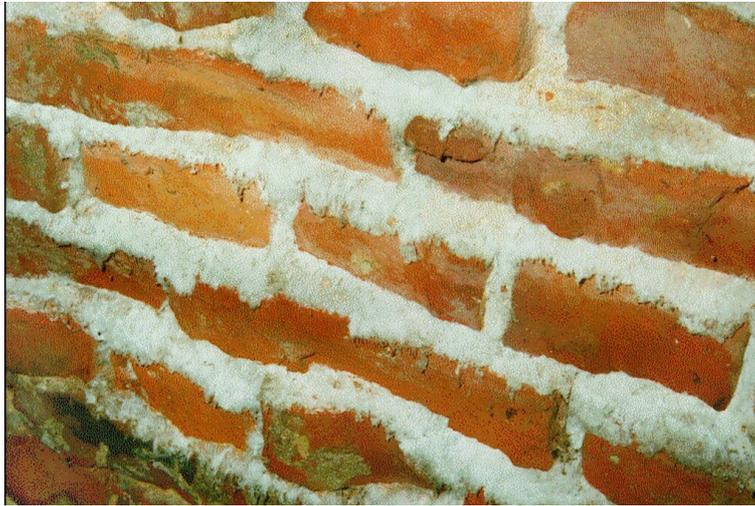
Figure 2: efflorescence on old lime-based mortar

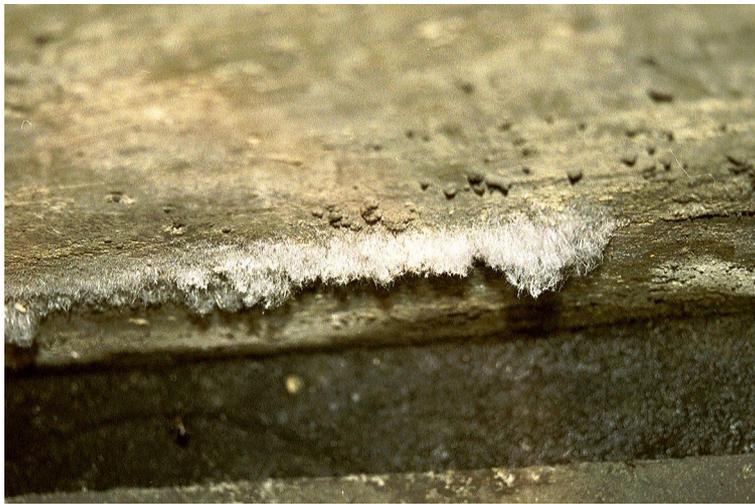
Figure 3: efflorescence at ground level on concrete from 1976

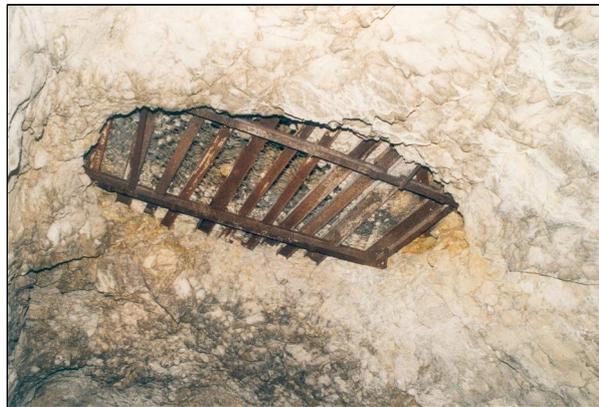
Figure 1: metal bars used as protection against falling, poorly consolidated materials from a karst

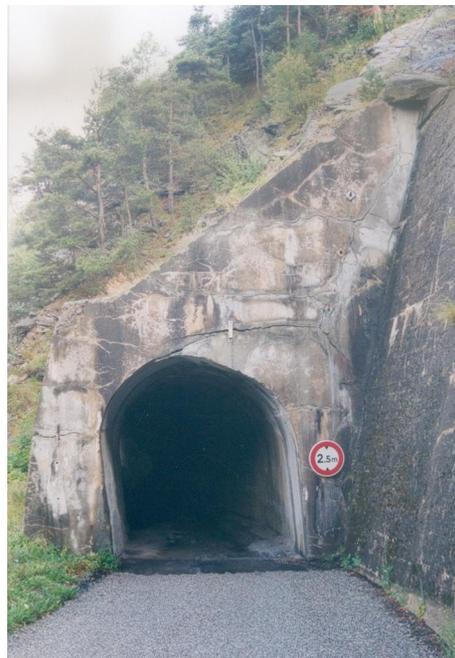
Figure 2: portal deformed by slope instability

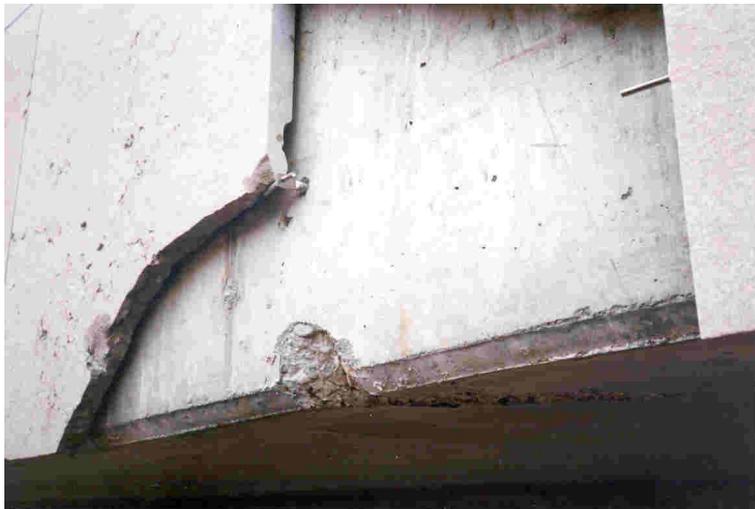
Figure 3: fallen cladding due to impact from a heavy goods vehicle

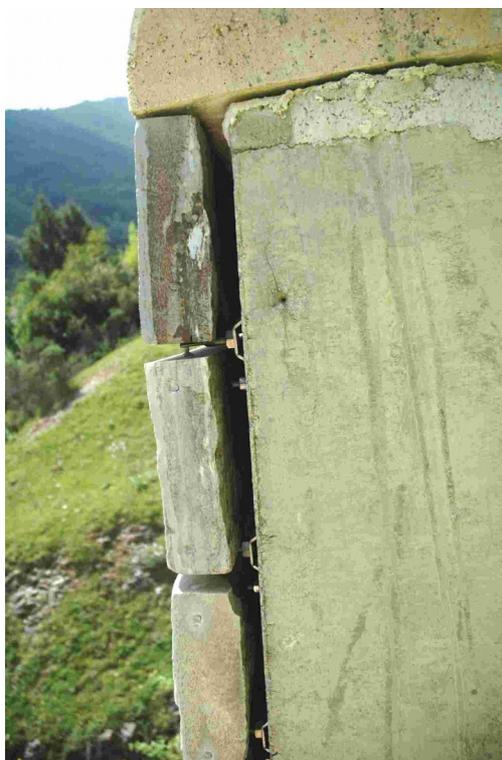
Figure 4: loosened panelling on a spandrel

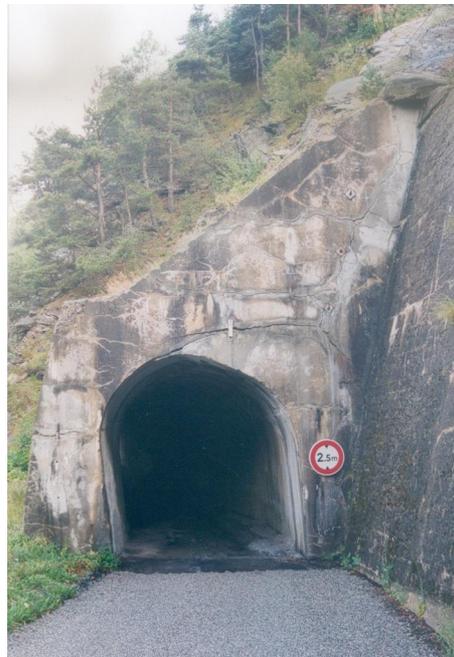
Figure 1: portal deformed by slope instability

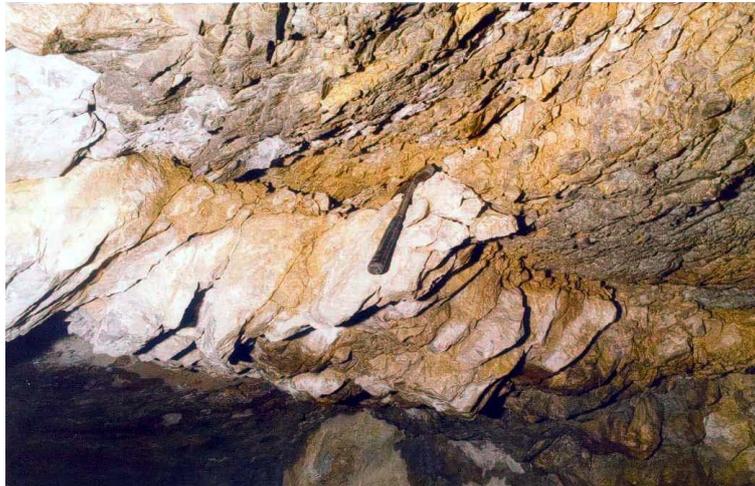
Figure 1: fractured mass separated from the surrounding rock by a clayey joint or "unstable rock bridge" (scaling is possible as an initial measure)

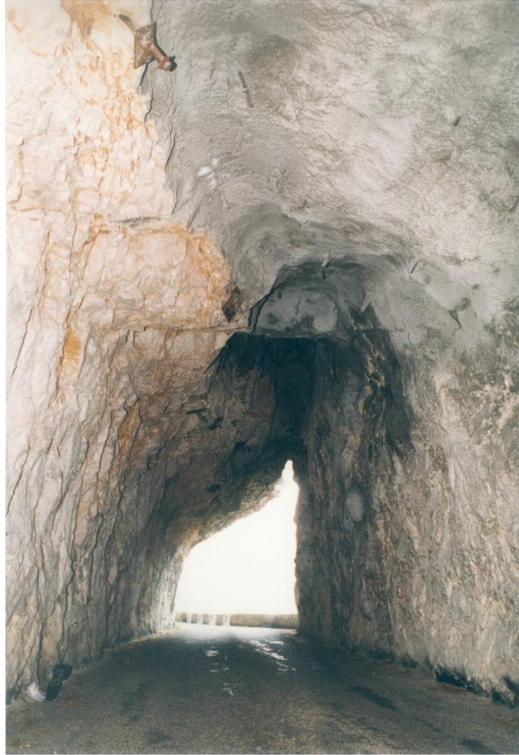
Figure 3: residual instabilities reinforced with sprayed concrete in the lateral reaming area

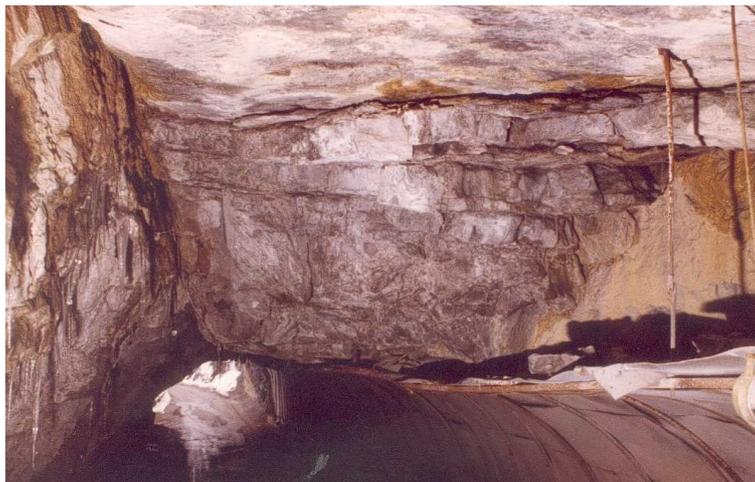
Figure 1: block that has fallen on metal sheeting, indicating weakening of the end of a limestone stratum (the presence of two damp vertical discontinuities at the sides constitutes a potentially hazardous long-term situation for the entire central part of the rock)

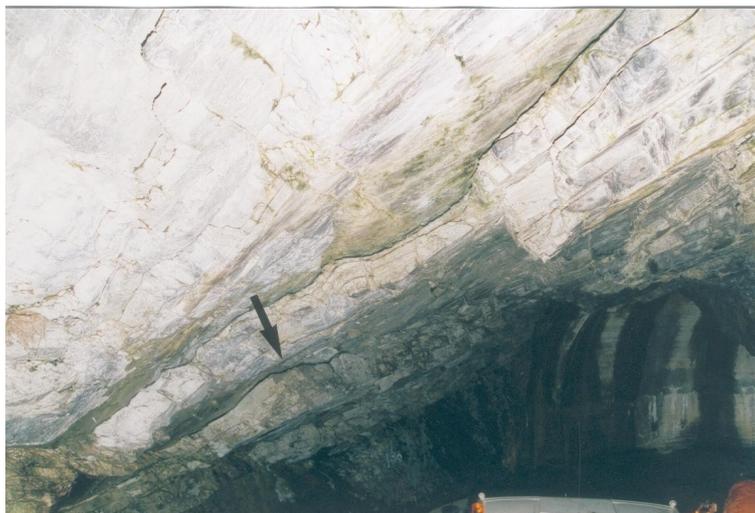
Figure 2: loosened plates at a 45° angle in the tunnel haunch

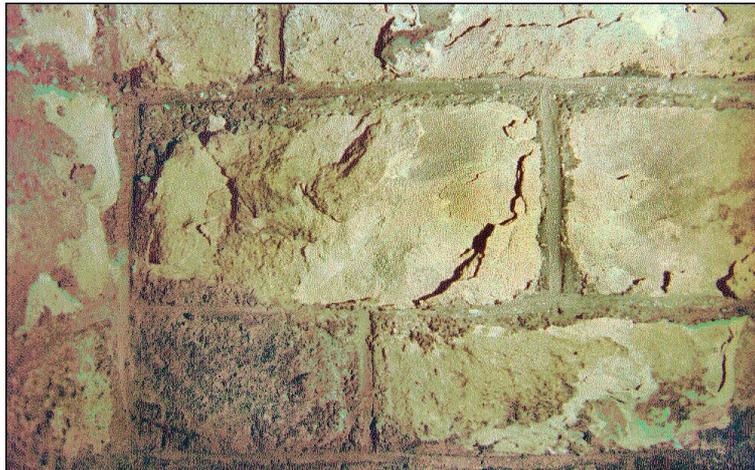
Figure 1: flaked stone (the sandstone masonry has been repointed some time ago using a compact and cement-rich mortar that has probably accelerated or even initiated the flaking process by enabling water to enter the stone)

The flaking process may be accelerated by the use of repointing mortars that are less permeable than the stones or the original mortar; water vapour is therefore transferred into the stone, whereas the more permeable original mortar tended to protect it.

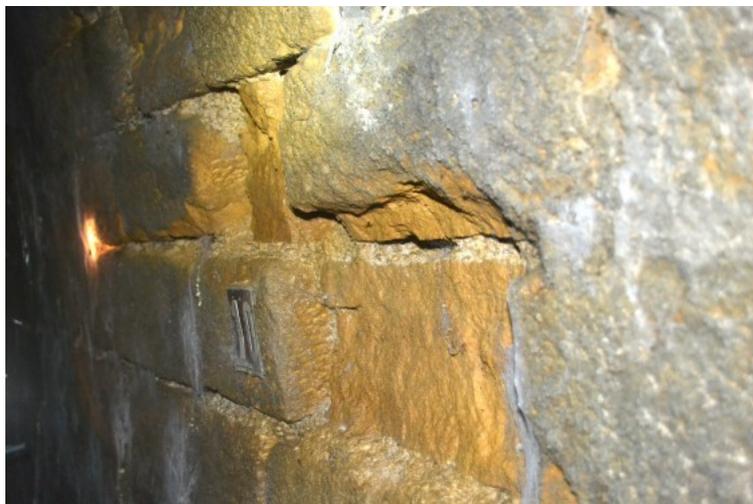
Figure 3: exfoliation and delamination of limestone masonry

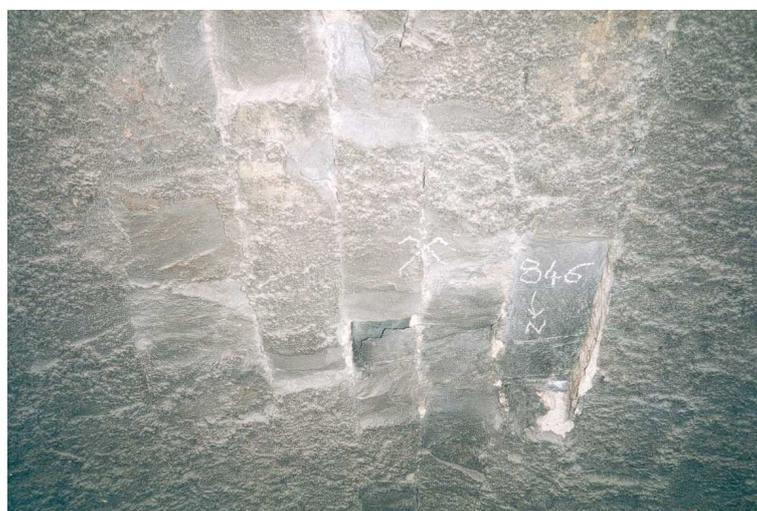
Figure 2: stone spalling at the crown (the parts that appear smooth are the scars left by fallen spalls up to 10 cm thick; note the almost total absence of mortar in the longitudinal direction, as well as a loosened spall still in place, held in place from the sides)

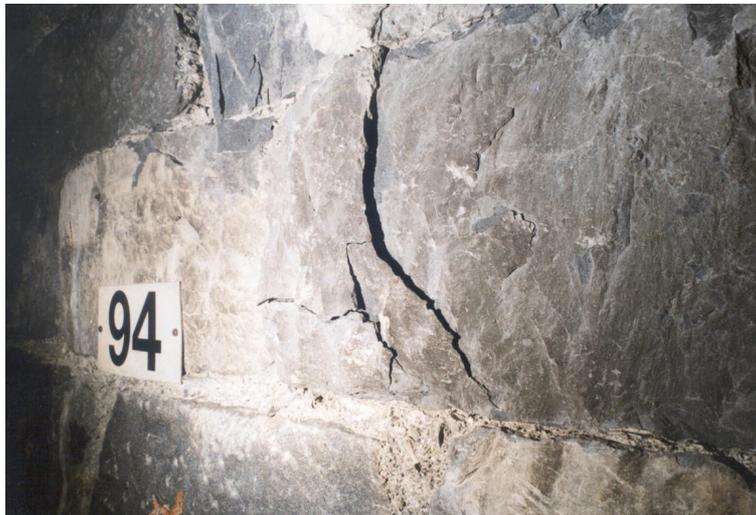
Figure 3: stone spalling on the side wall (the spall has broken away 15 mm from the wall and cannot be detached by hand; the upper and lower stones are in direct contact, as there is no mortar)

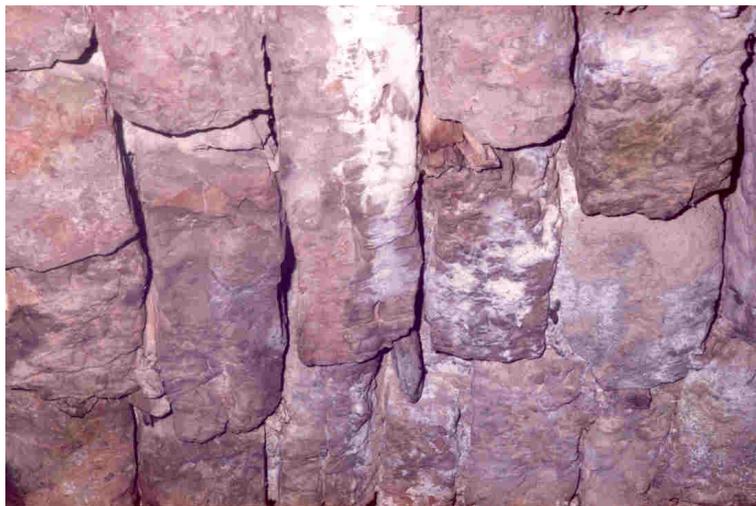
Figure 2: joint disintegration, typical of a lack of maintenance (wood dowels were probably used to secure stones or stop local water ingress; the stones, although of good quality, have almost come loose)

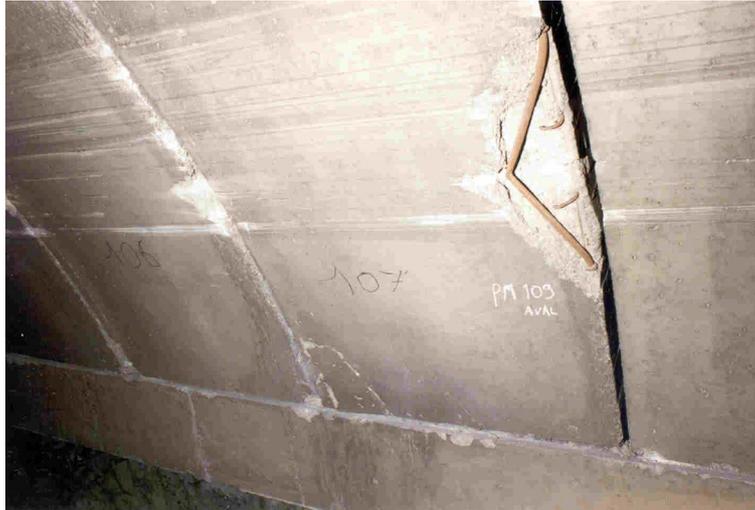
Figure 1: chipped thin prefabricated element following an impact (traces of friction)

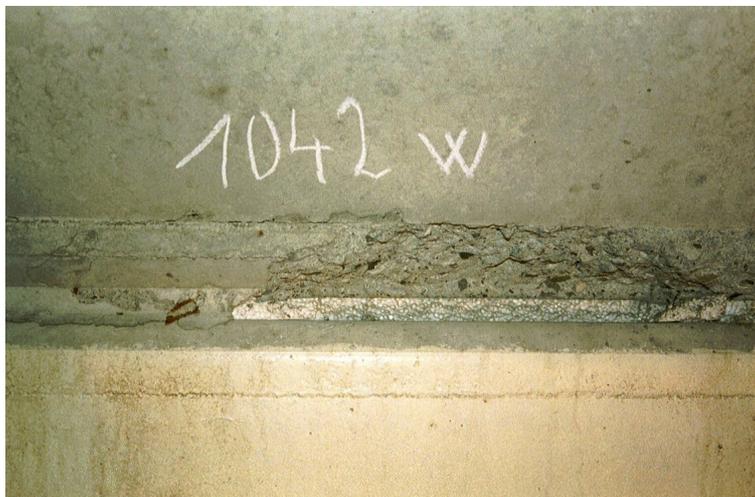
Figure 2: chipping at the bottom of a ventilation slab support that probably occurred during form removal; on the left, a spall remains that has not yet fallen

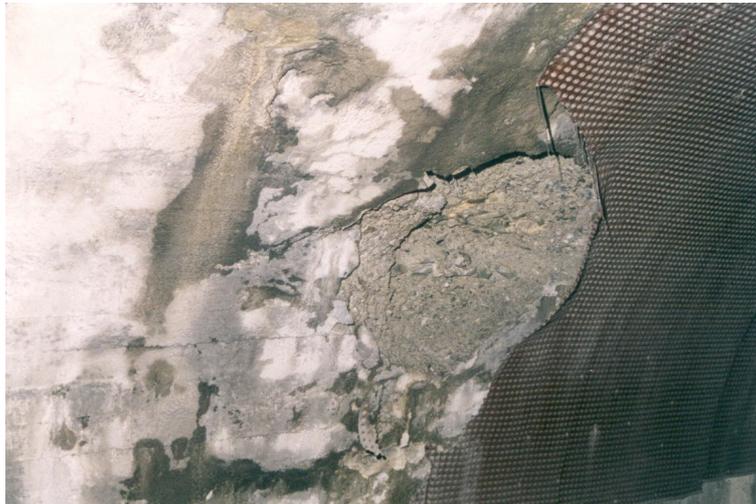
Crack 1: concrete deteriorated by dissolution and leaching, then freezing

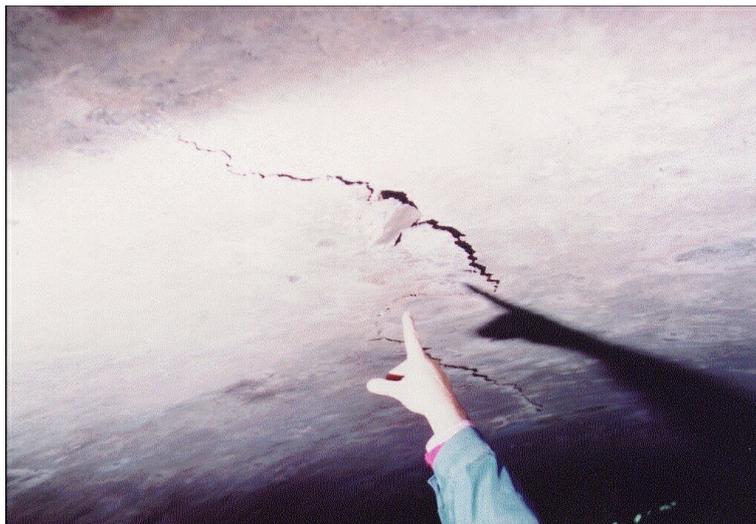
Figure 2: start of concrete shearing in the crown (the shear crack is shown clearly here; the edge is fragile)

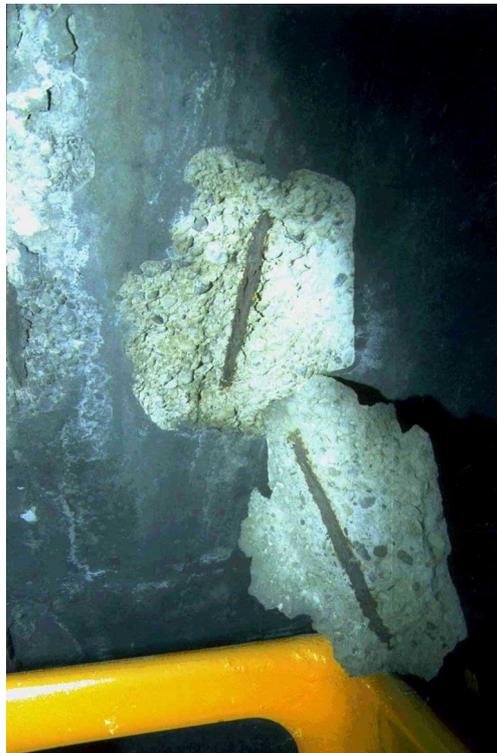
Figure 1: 2 to 3 cm thick spall following corrosion of a reinforcement (concrete from 1963)

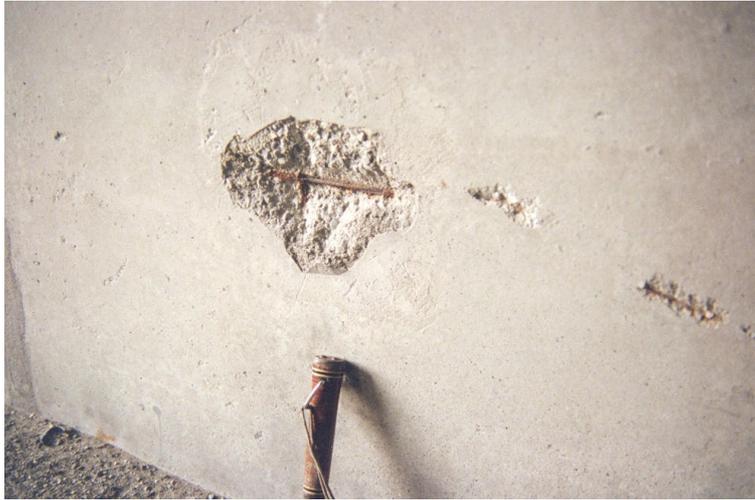
Figure 2: spalling in recent concrete

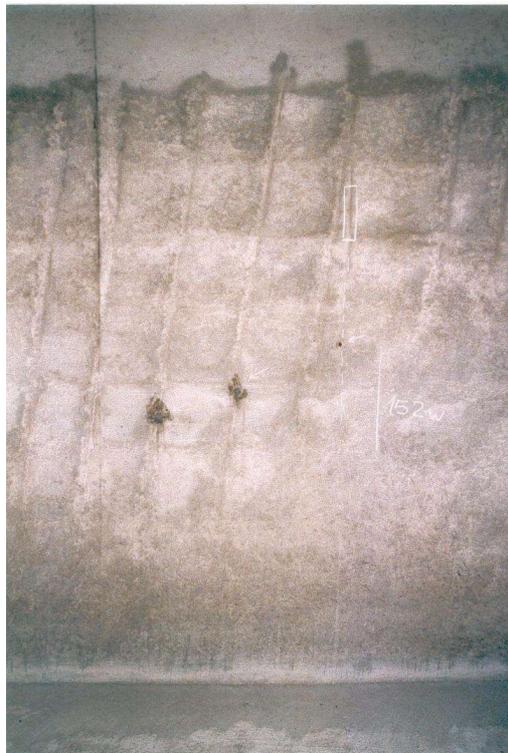
Figure 3: outline of the reinforcements in the side wall ring

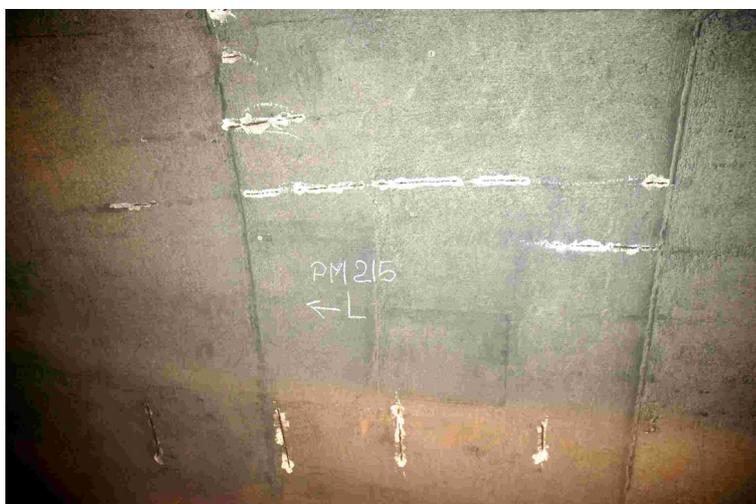
Figure 4: concrete spalling due to corrosion and thin covering of reinforcements

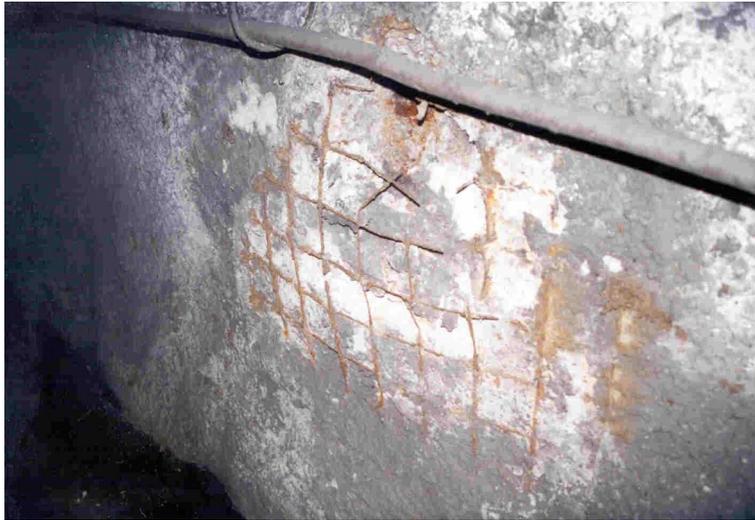
Figure 1: insufficient covering of the welded mesh (poor workmanship)

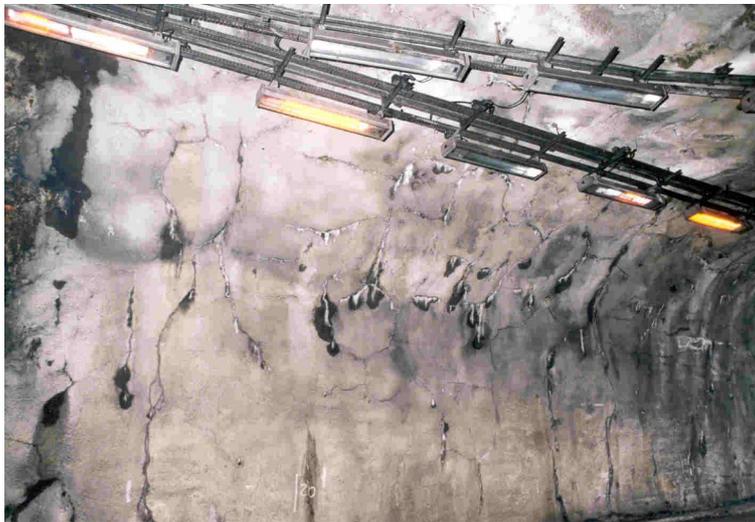
Figure 2: sprayed concrete crazing over damp rock (shrinkage of non-reinforced concrete)

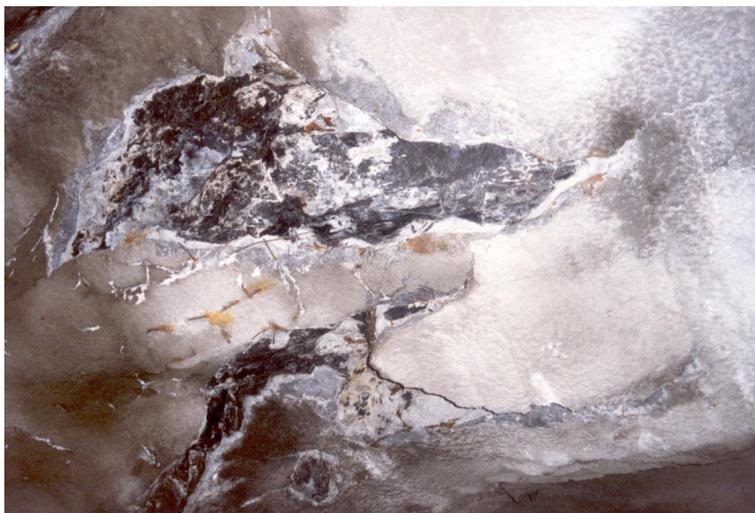
Figure 3: sprayed concrete that has fallen from a roof section (combination of incorrect spraying on damp and unstable shale ground subjected to prolonged freezing)

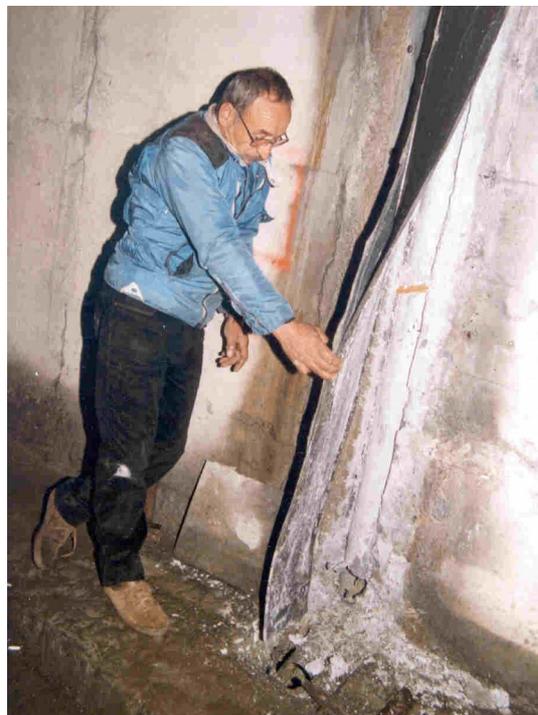
Figure 2: loosened sealing strip (the bottom of the collection system has been destroyed by freezing and is blocked)

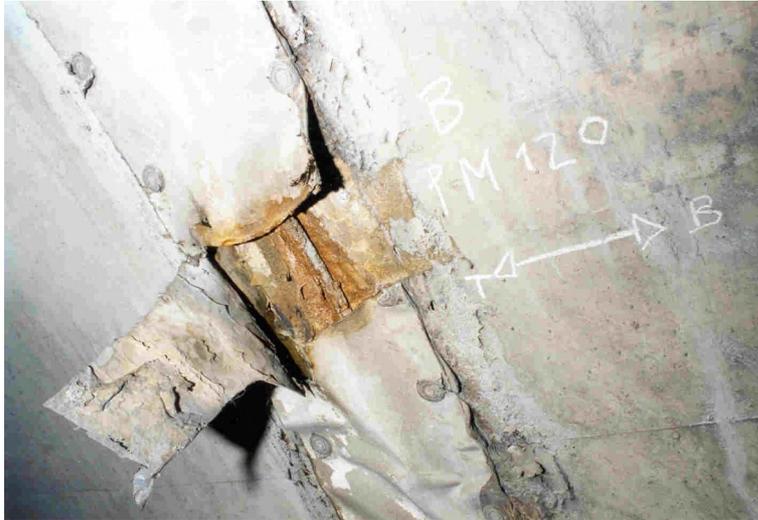
Figure 3: sealing strip and removable seal (here PRT seal and Hypalon sealing strip) destroyed by friction from heavy goods vehicles

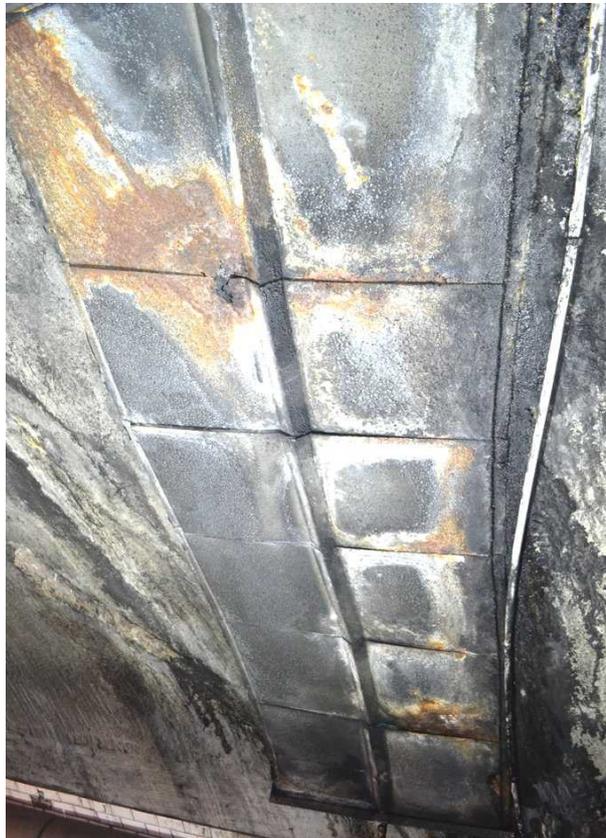
Figure 4: corroded and leaking zinc-plated steel intrados drain

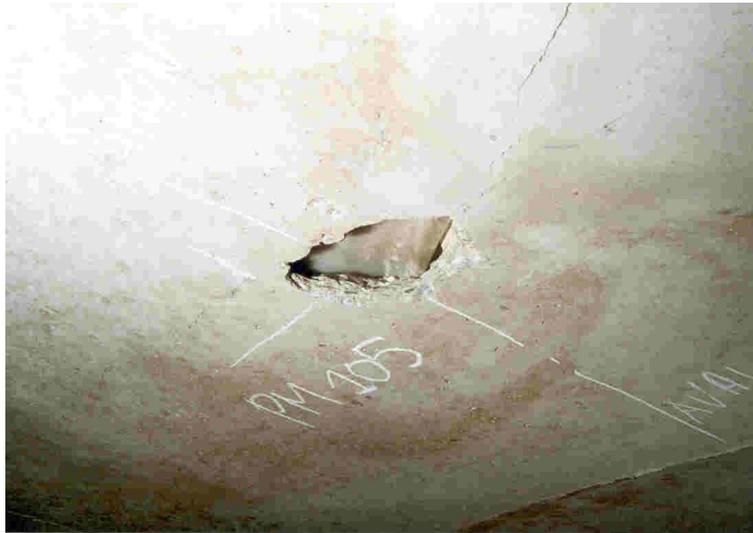
Figure 1: fold in membrane (localized hollow-sounding area)

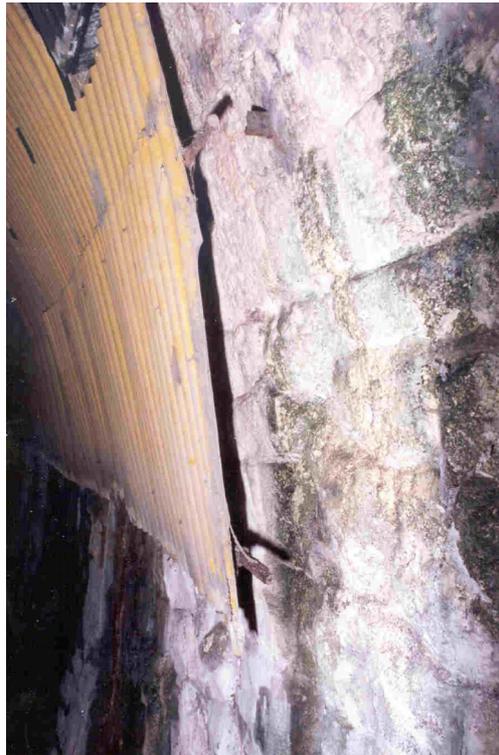
Figure 1: loss of a metal element and rupture of anchorage

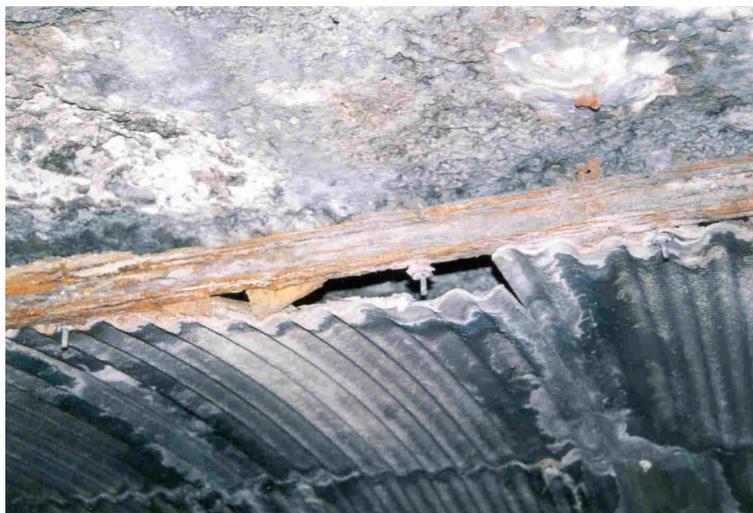
Figure 2: fibre-cement panels (significant oxidation of the support rails and an element which has become unfixed)

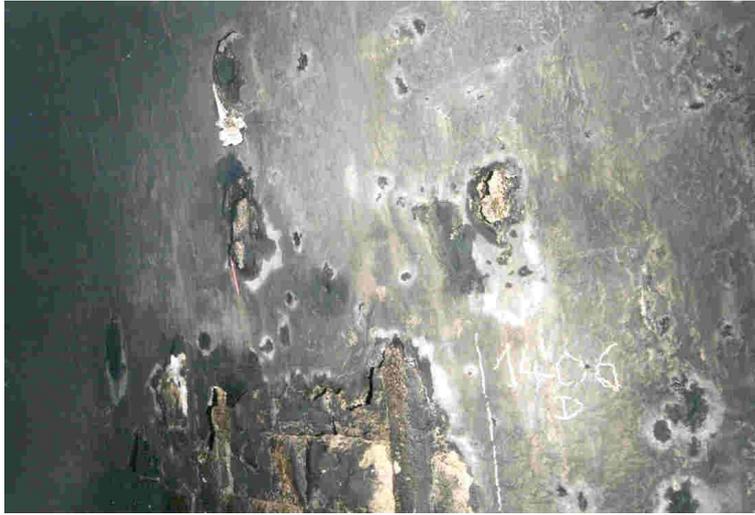
Figure 1: deterioration of a resin membrane installed on masonry

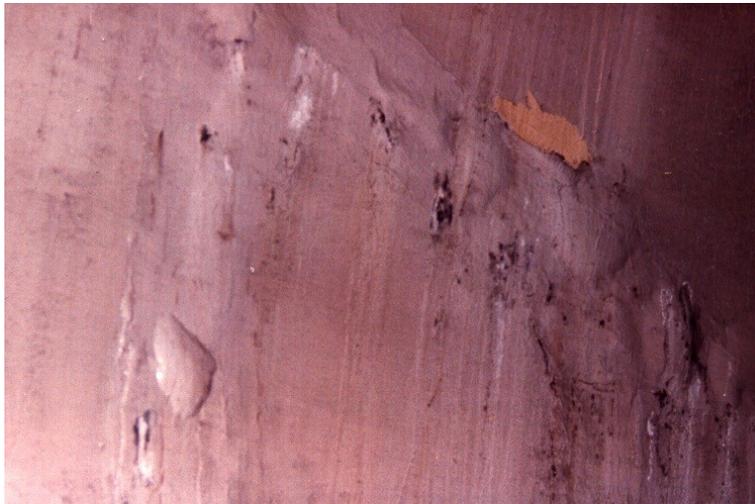
Figure 2: blisters in the resin membrane filled with pressurised water

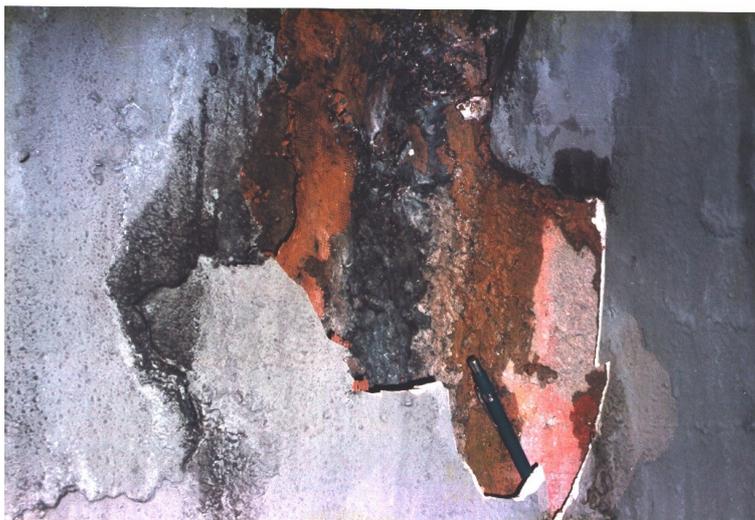
Figure 3: break up of tanking under the effects of freezing

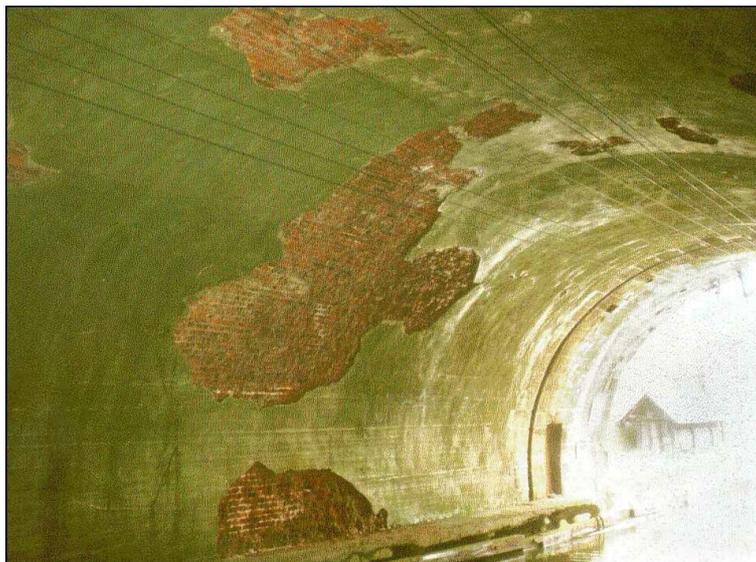
Figure 2: fallen coating (brick arch in a canal tunnel)

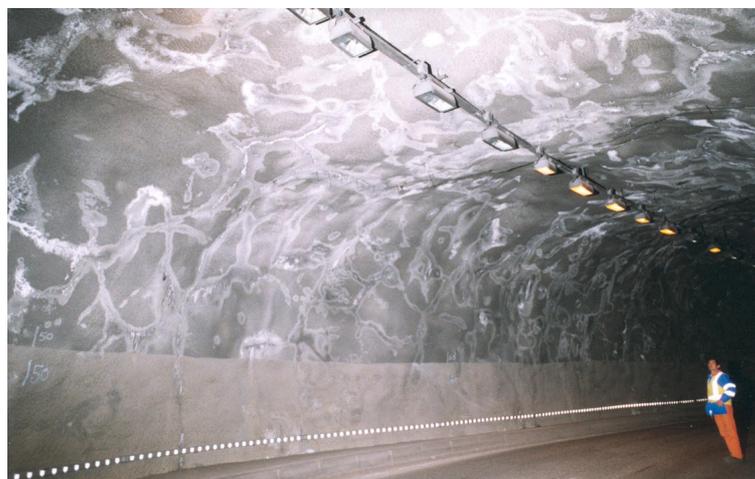
Figure 2: same tunnel after a few years in operation

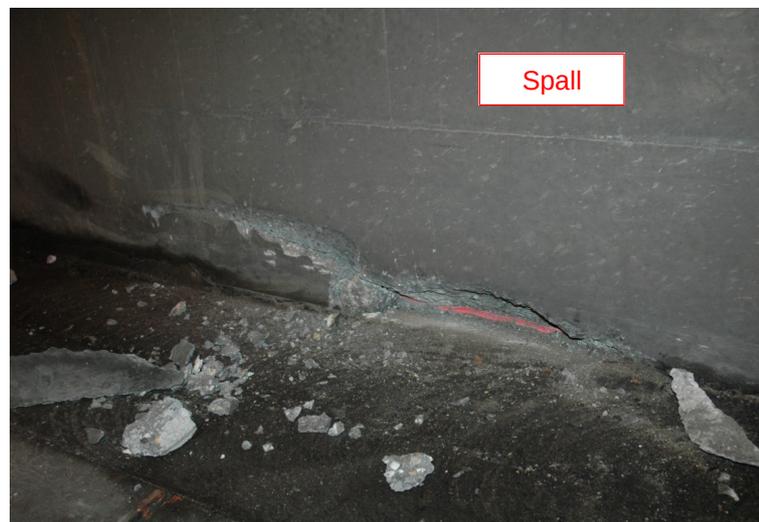
Figure 2: concrete spalling along the joint between the walkway and the side wall

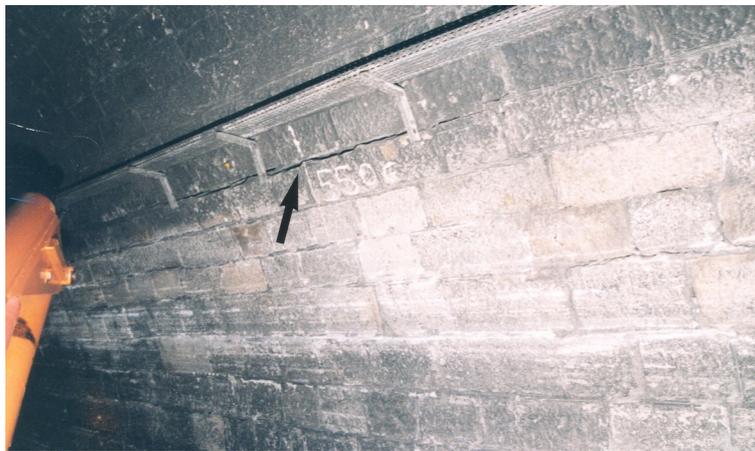
Figure 1: horizontal crack following deformation of the masonry (asymmetrical squeezing) confirmed by traces of friction from vehicles (mortar is still present on one side of the crack)

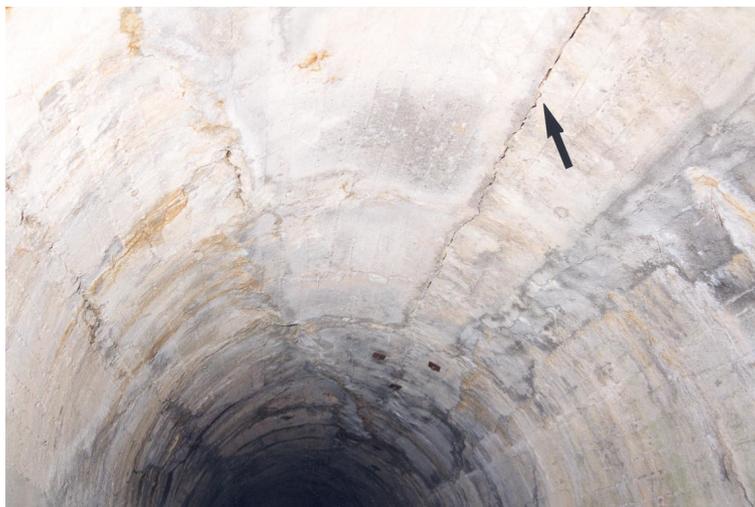
Figure 2: horizontal crack in cast concrete related to deformation of the lining under the thrust of the surrounding ground (the crack forms along the construction joint)

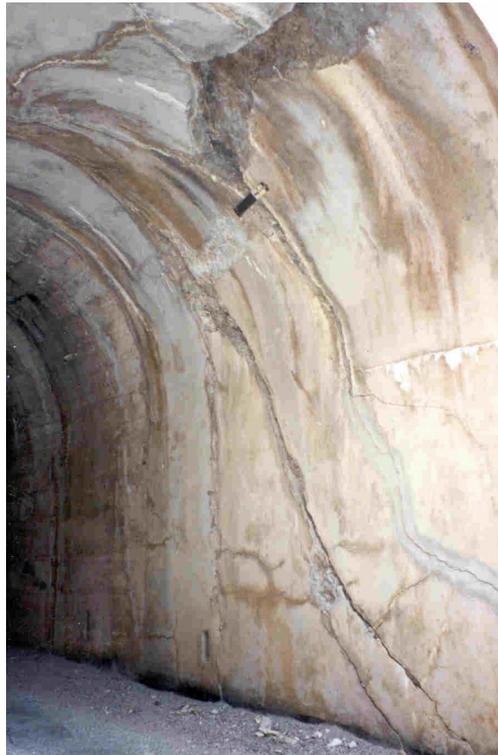
Figure 1: network of diagonal cracks in a concrete arch deformed by thrust from the ground above (a piece of concrete has already fallen due to rupture in the haunch, and a crack gauge is measuring a crack – the tunnel had to be closed a few years later)

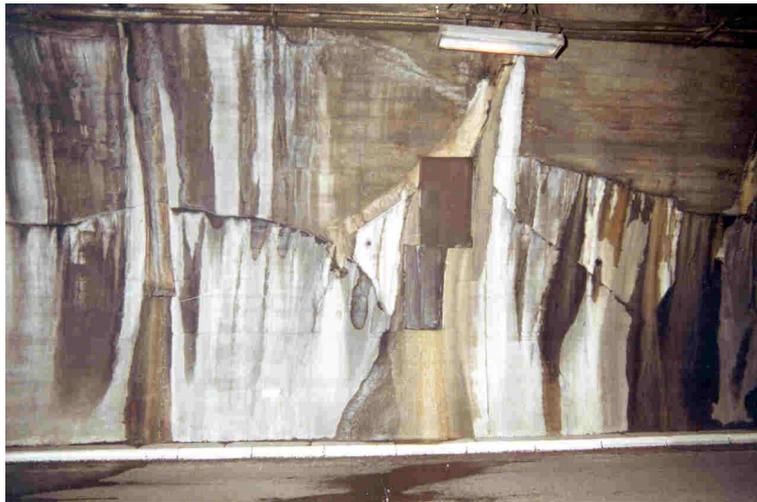
Figure 2: development of shrinkage in concrete from 1970 without a waterproof membrane applied to the extrados
