Road tunnel civil engineering inspection guide

Book 2: Catalogue of deteriorations

January
2015

Centre d'Études des Tunnels

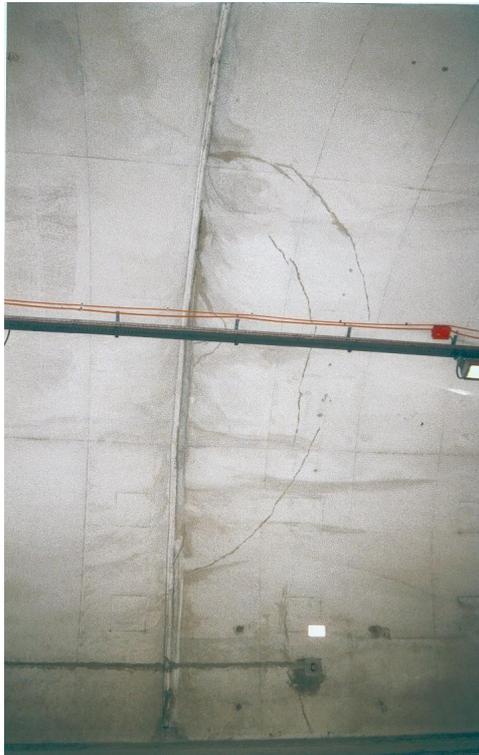
Figure 1: nested curved cracks in the haunch (the bottom of the photo corresponds to the walkway; concreting was carried out from right to left)

Several nested curved cracks have sometimes been observed, with no associated instability.

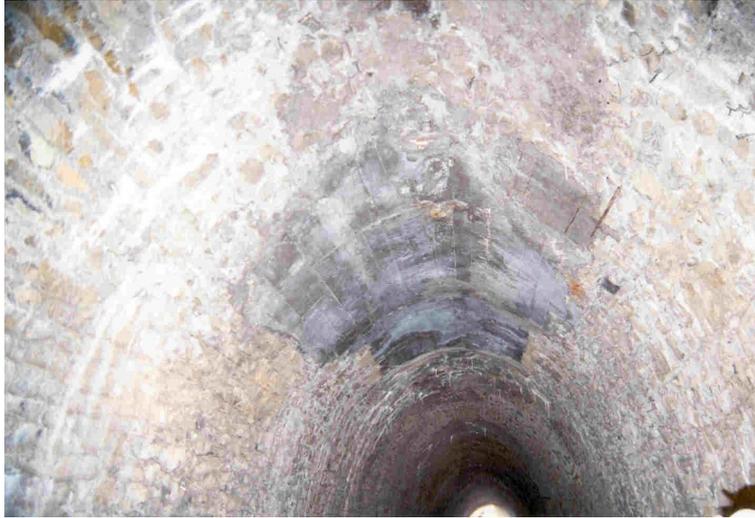
Figure 3: symmetrical squeezing in the crown (already partially repaired with non-reinforced cast concrete, the deformation is continuing, crushing the remaining crown stones and concrete)

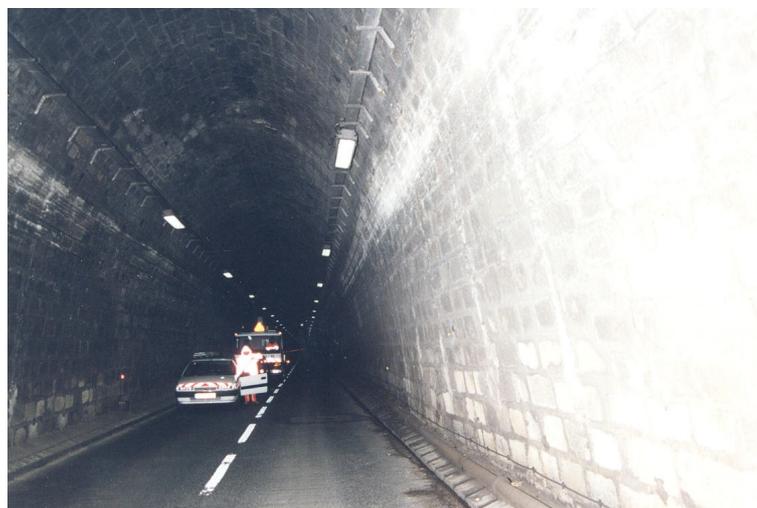
Figure 5: asymmetrical squeezing (the light part has lost its original curve)

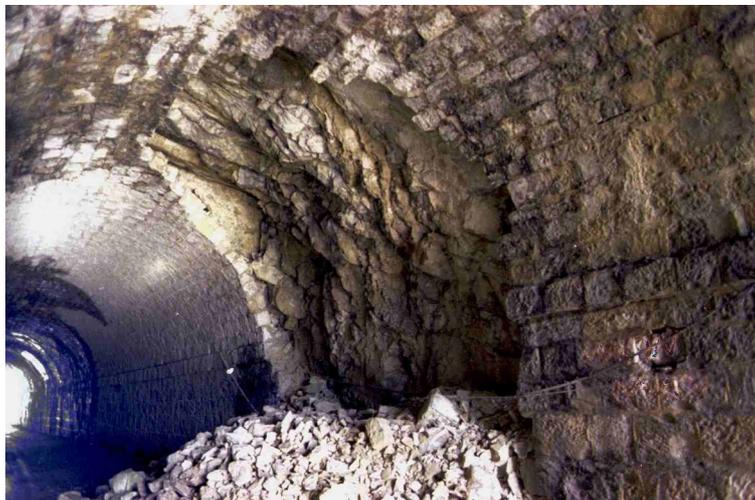
Figure 1: half the arch has fallen due to crushing of the side wall, consisting of very deeply delaminated, weak stones (this permanent damage was preceded by bulging of the side wall, which was not strengthened in time; the ground was not the cause of the deterioration)

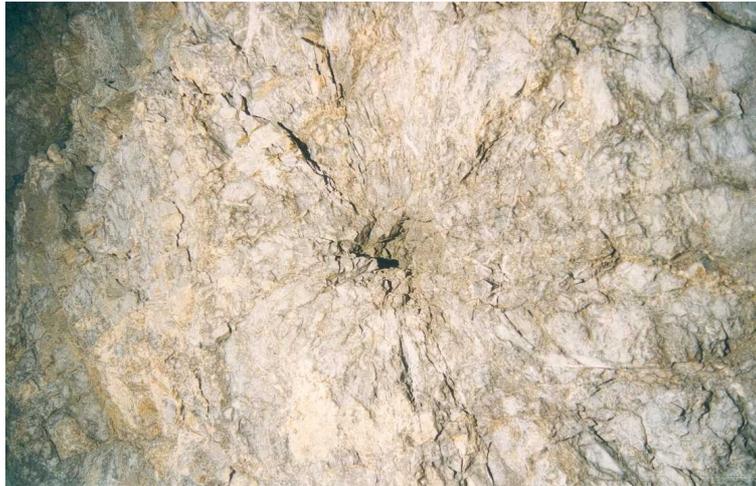
Figure 1: limestone excavated at the beginning of the 19th century [fractures can be seen radiating from a blast hole; the entire rock is loosened and unstable]

In many old unlined tunnels, unstable "rings" can be seen at blast hole bottoms, made up of a large number of radiating cracks .

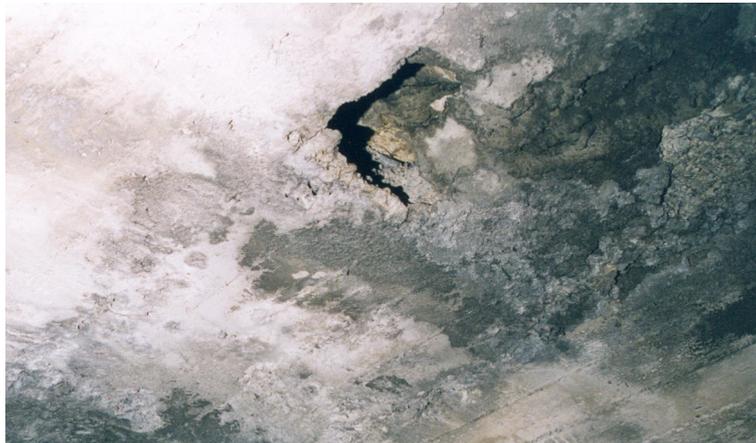
Figure 2: void dating back to construction, on the extrados of highly deteriorated concrete [the hollow-sounding lining is unstable around the opening]

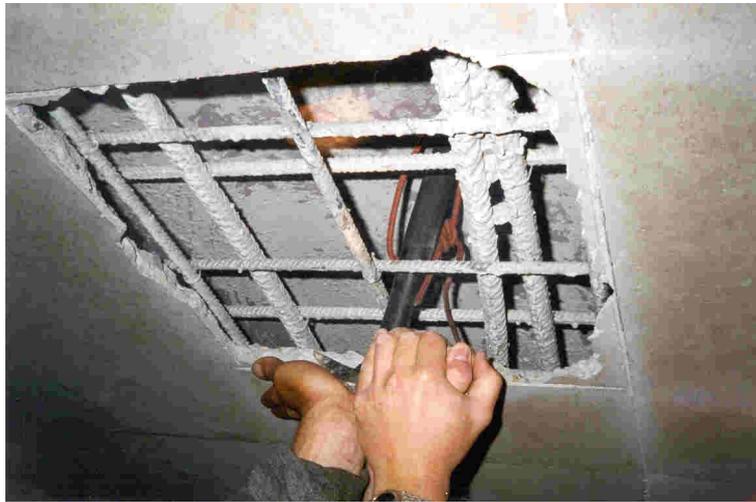
Figure 1: investigation window opened in a very hollow-sounding area [extrados void of 27 cm due to a concreting defect]

Located in roof sections or in haunches, a hollow-sounding area may indicate poor spreading of the concrete within the reinforcement layers or even a concreting defect (poor workmanship).

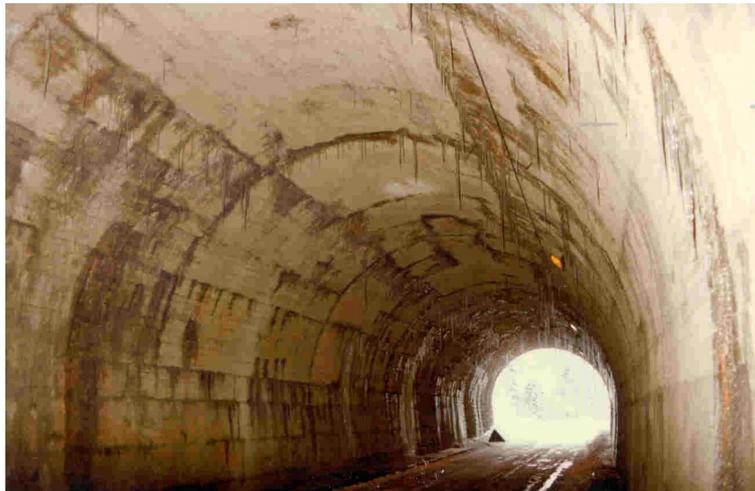
Figure 1: gravel pockets on a concrete lining from 1936 [each layer of concrete is highlighted by an alignment of permeable and perfectly horizontal gravel pockets due to poor concreting]

Gravel pockets are common in old concretes applied in many small batches with poor vibration. As preferred passages for water ingress, these areas may deteriorate rapidly, sometimes becoming loose and unstable, leading to localized weakening of the lining. In the absence of aggressive agents, their strength over time can be excellent.

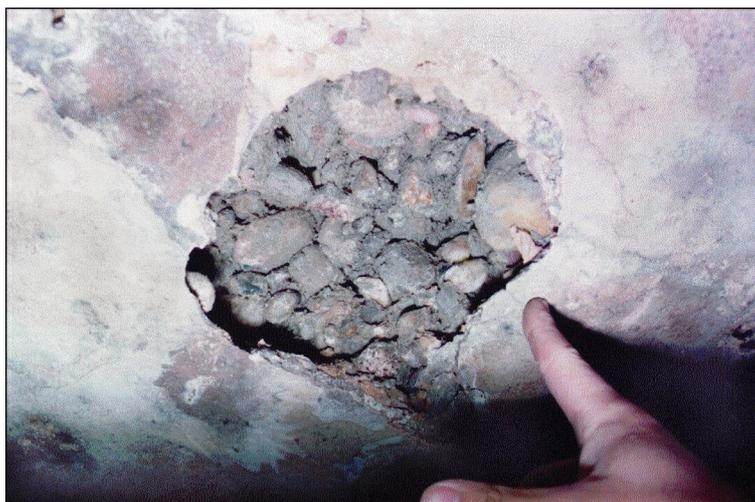
Figure 2: gravel pocket initially hidden by a film of laitance [its spread can only be mapped using hammer tapping]

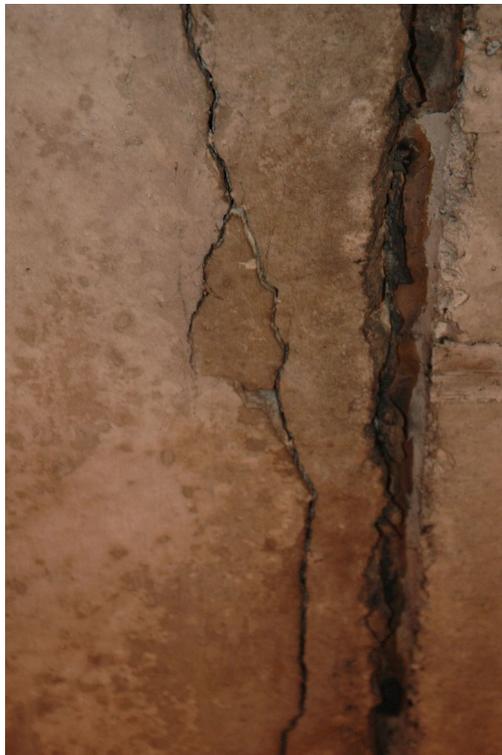
Figure 1: deterioration in an elastomer joint

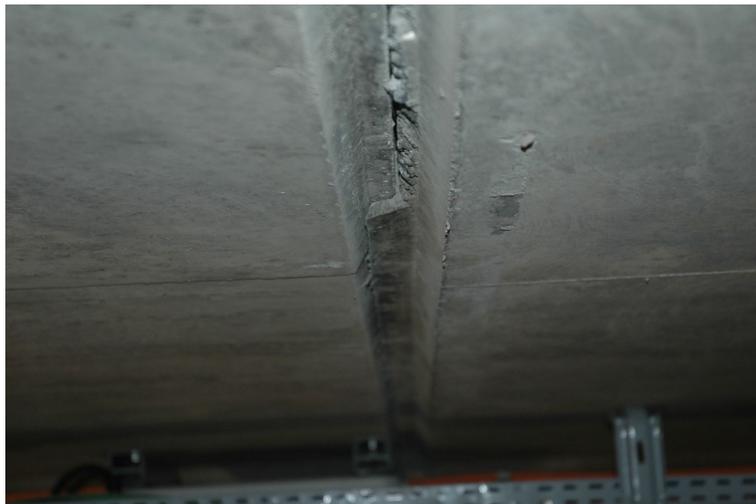
Figure 4: deterioration of a dry joint [movement between rings or concrete breakage during form removal]

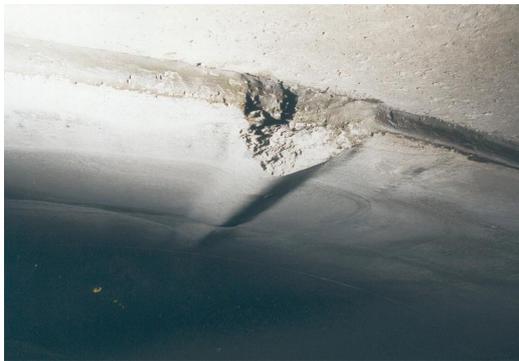
Figure 1: localized formwork deformation

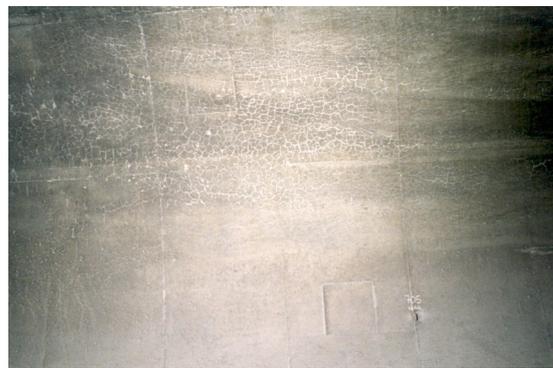
Figure 2: dense crazing

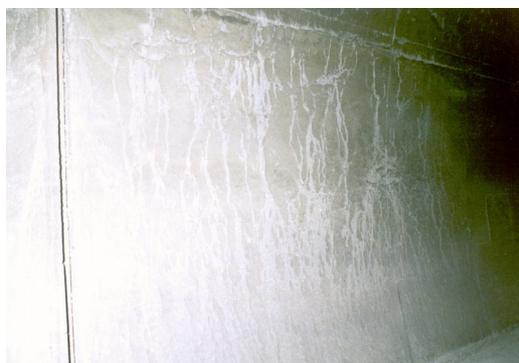
Figure 3: bleeding

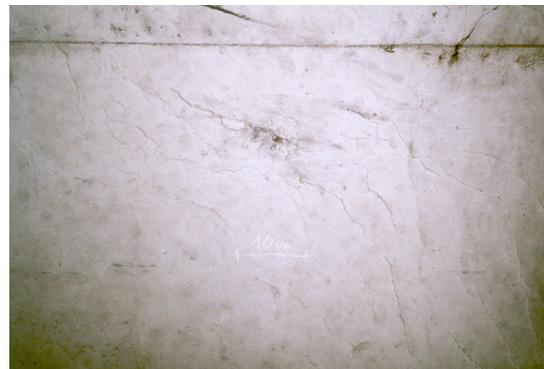
Figure 4: network of skin cracks

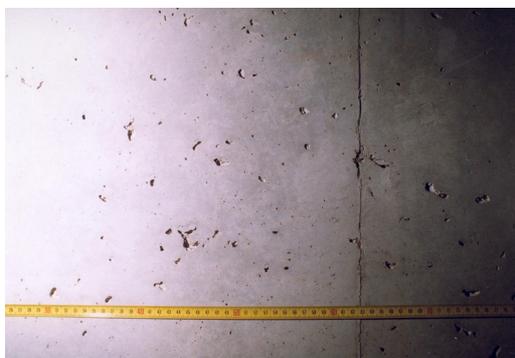
Figure 5: bubbling (or blistering)

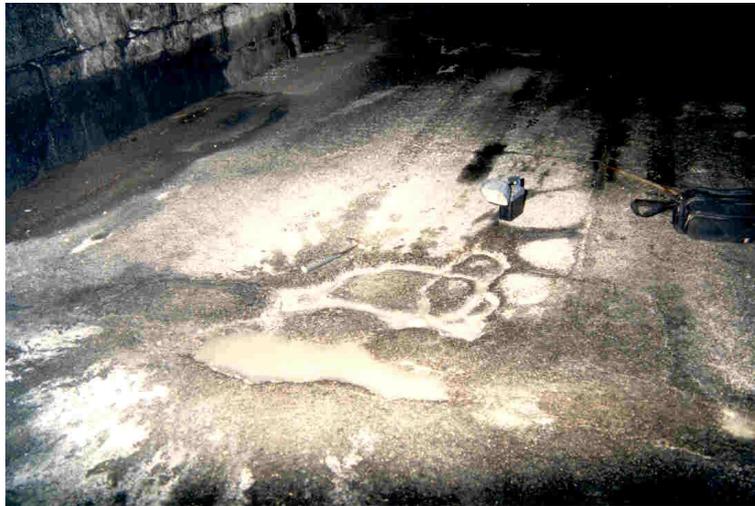
Figure 1: crazing and potholes [foundation saturated with water, with areas dissolved under the effect of pumping resulting from the passage of vehicles]

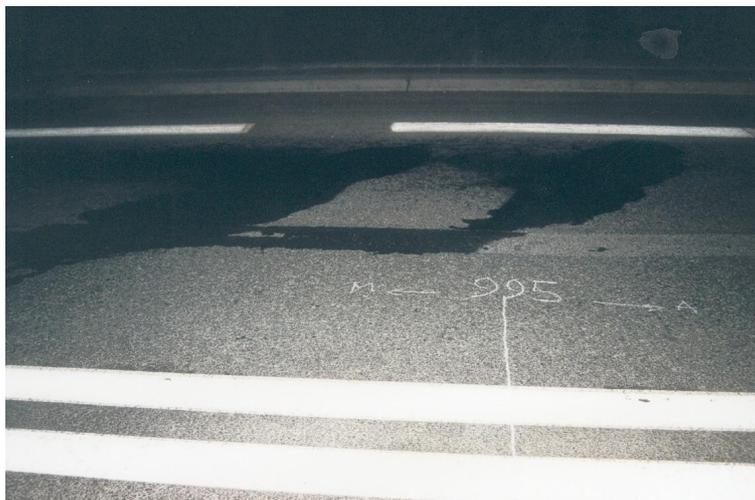
Figure 2: water rising through asphalt

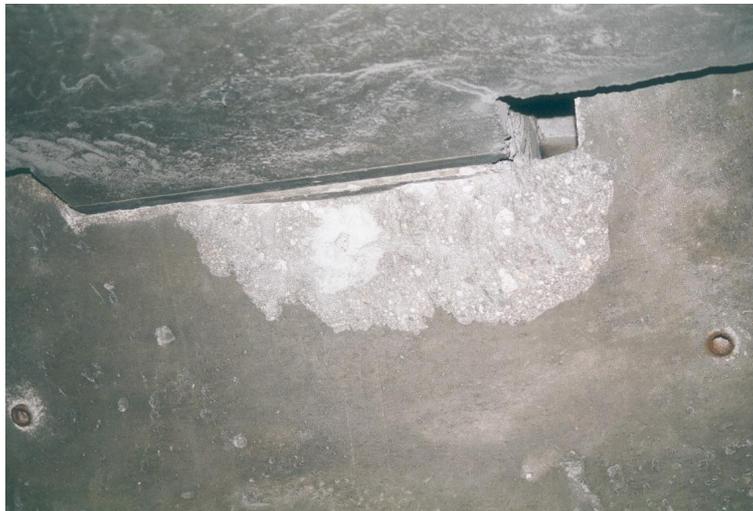
Figure 1: spall fallen from beneath a trench

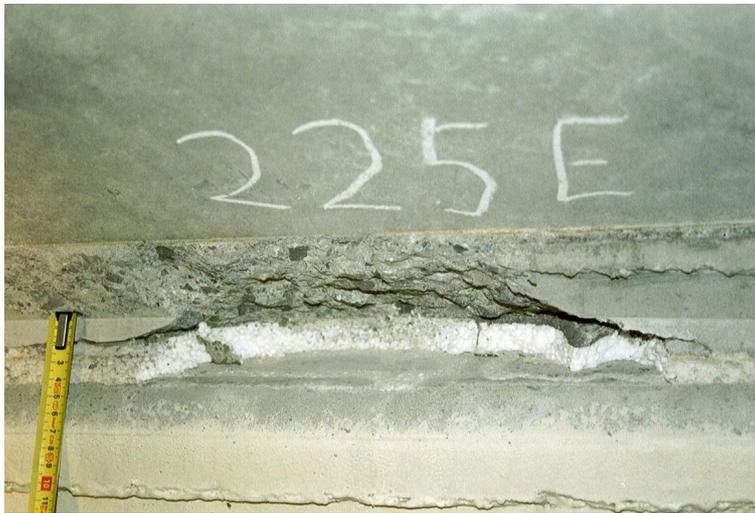
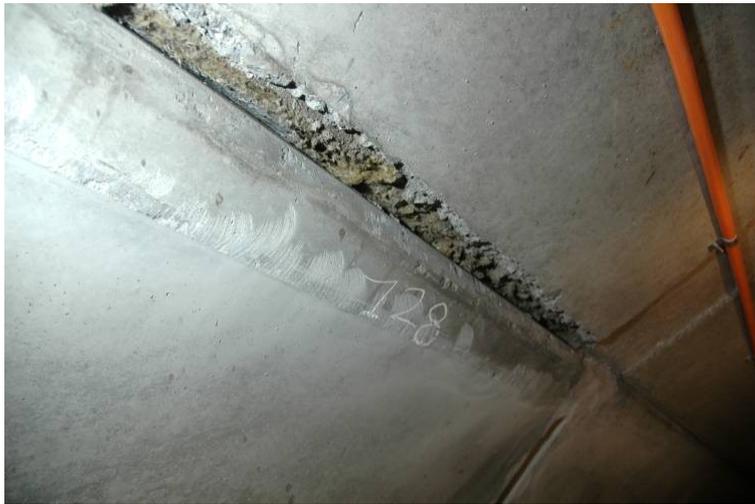
Figures 2a and 2b: chipping at the edges of slabs

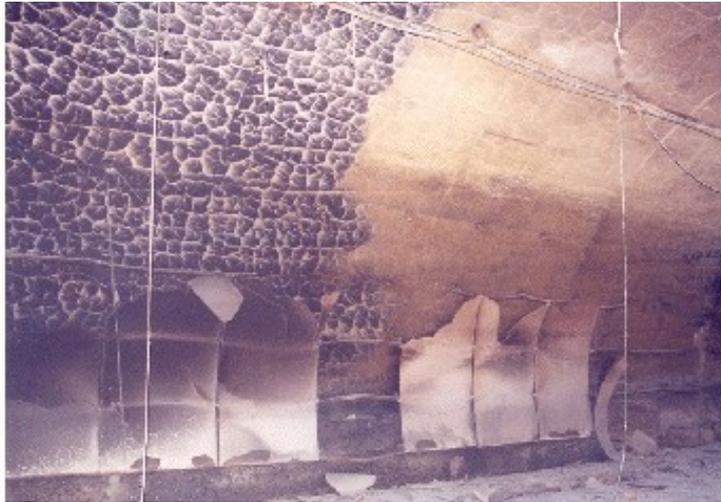
Figure 1: crazed concrete [thermal limit clearly shown where soot is deposited on the crazing], at a distance of 120 m from the heavy goods vehicle that caused the fire in the Mont-Blanc tunnel [no other vehicle involved]

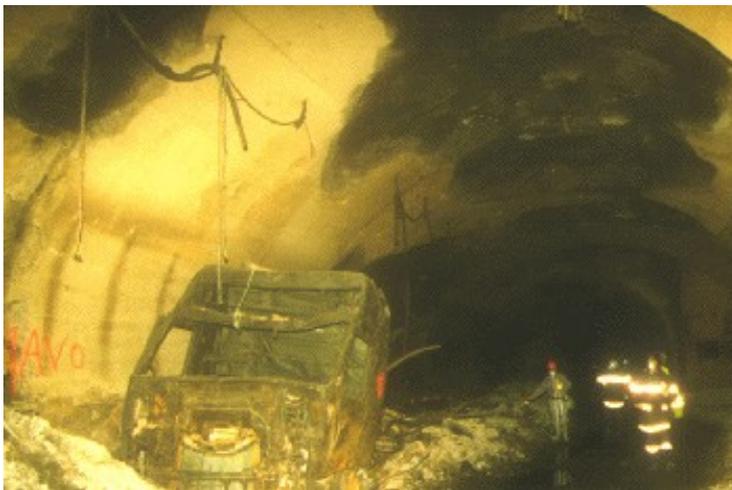
Figure 2: craters 30 to 60 cm deep created in the arch by the fire next to the heavy goods vehicle that caused the fire [Mont-Blanc tunnel]

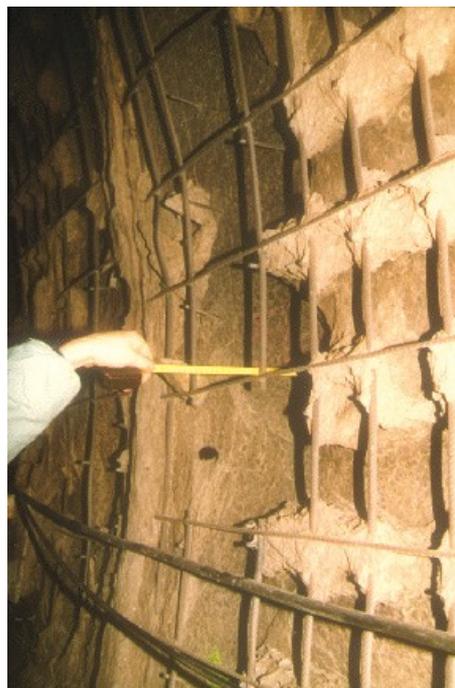
Figure 3: deep spalling revealing the intrados reinforcements, following the ten-hour fire in the Channel Tunnel in 1996, involving a heavy goods shuttle. In the most affected area, at the heart of the fire in this tunnel, (formed of prefabricated reinforced concrete segments), the damage locally affected the tamping mortar.

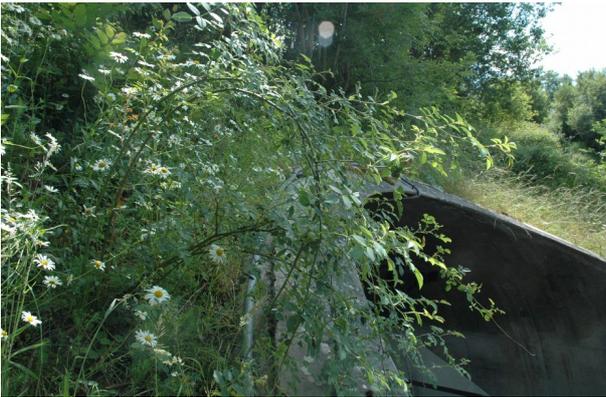
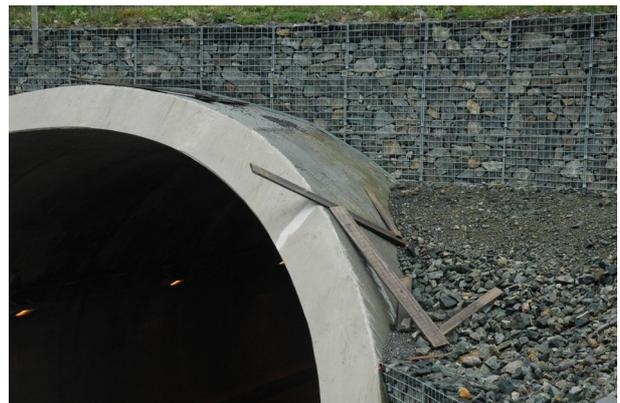
Figures 1a and 1b: dense vegetation that may create instabilities at portals – Objects that may fall on the carriageway

- dense vegetation that may create instabilities at portals,
- objects that may fall on the carriageway,
- faulty fixtures (cable tray hangers, cameras, power cables in the roof section),
- cast iron manhole or drain covers that are missing or that obstruct the traffic.

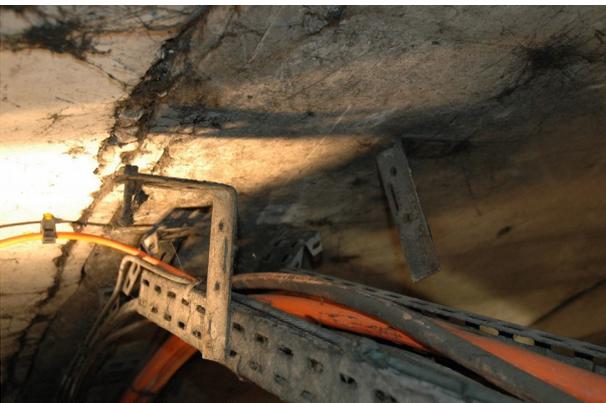
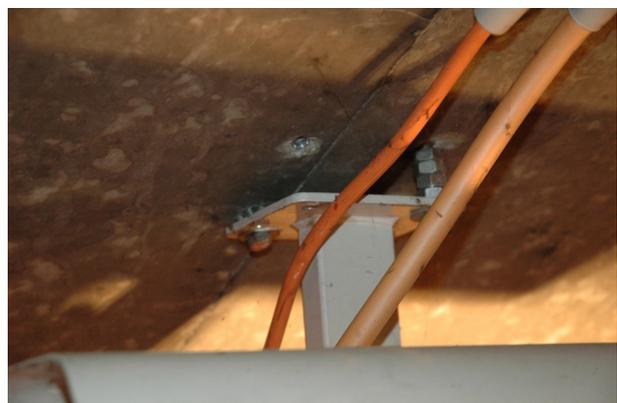
Figures 2a and 2b: partially or totally severed cable tray hangers or camera fastenings

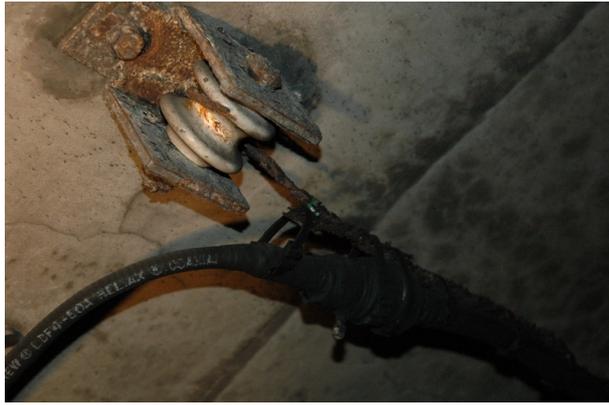
Figure 2c: broken plastic power cable fixture in the roof section

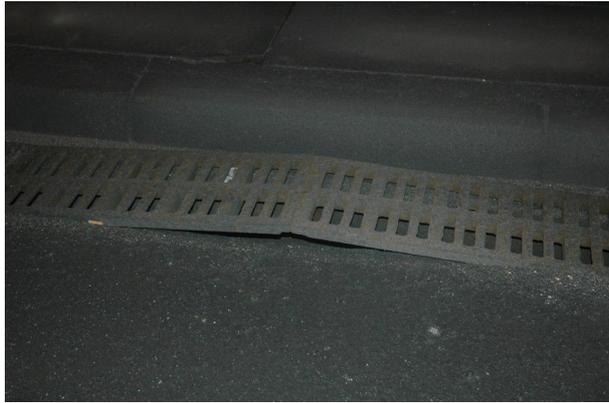
Figure 3: incorrectly positioned cover blocking the gutter
